H&S Bosma Dairy Lagoon Nos. 1, 2, and 3

Administrative Order on Consent Docket No. SDWA-10-2013-0080

Prepared for H&S Bosma Dairy

H&S Bosma Dairy Lagoon Nos. 1, 2, and 3 Interim Soil Sampling Plan

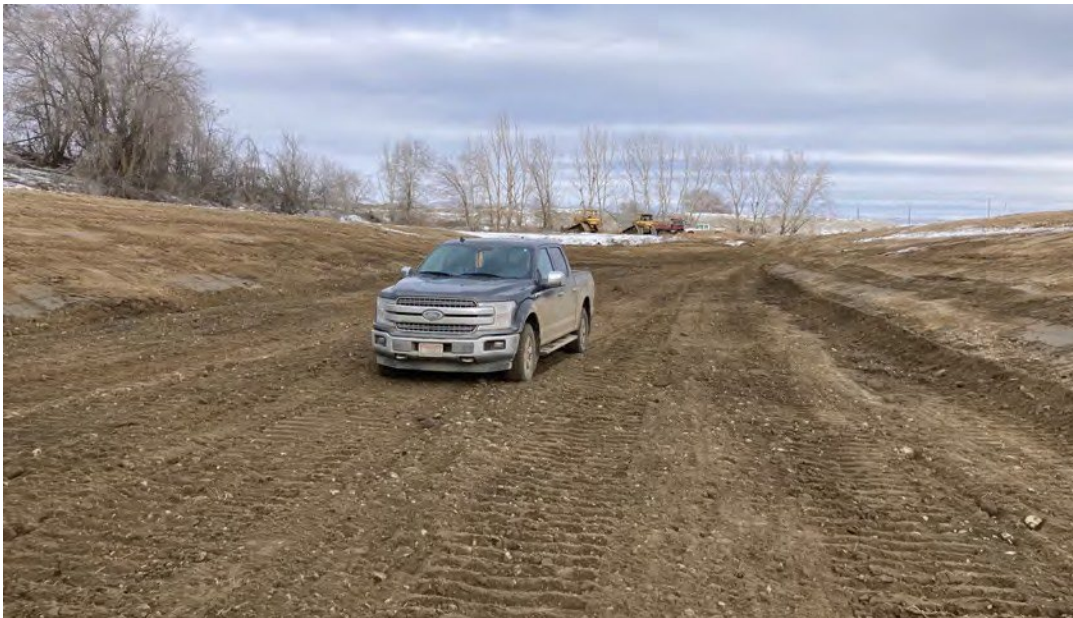
Photograph 1

Condition of Lagoon No. 3 in December 2021 Following Manure and Liquids Removal

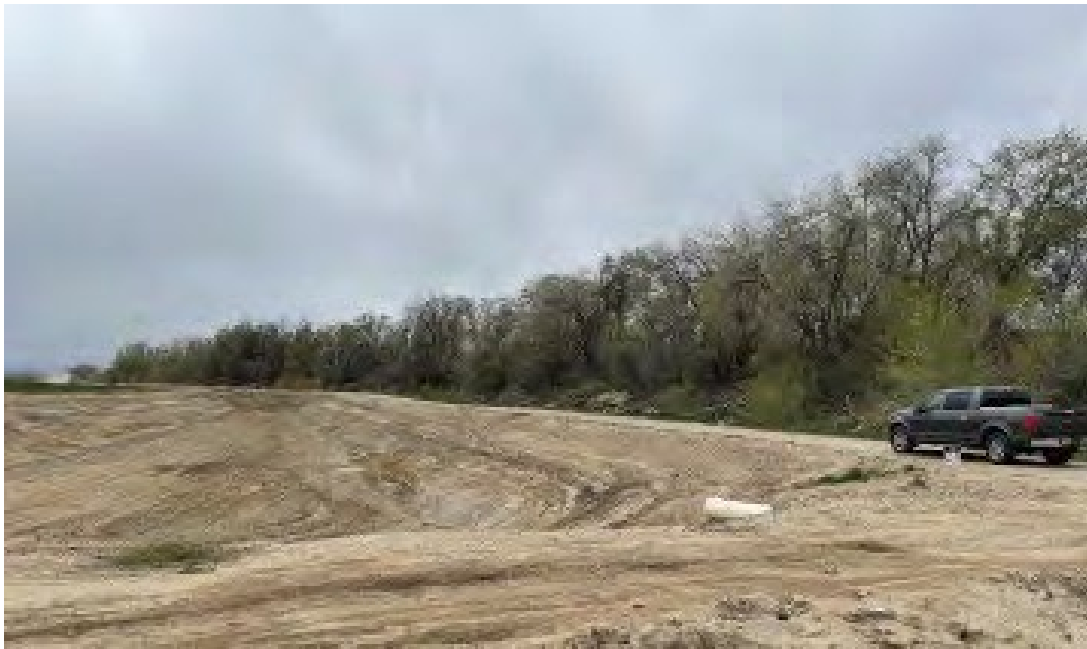
Photograph 2
Condition of Lagoon No. 3 as of April 4, 2022

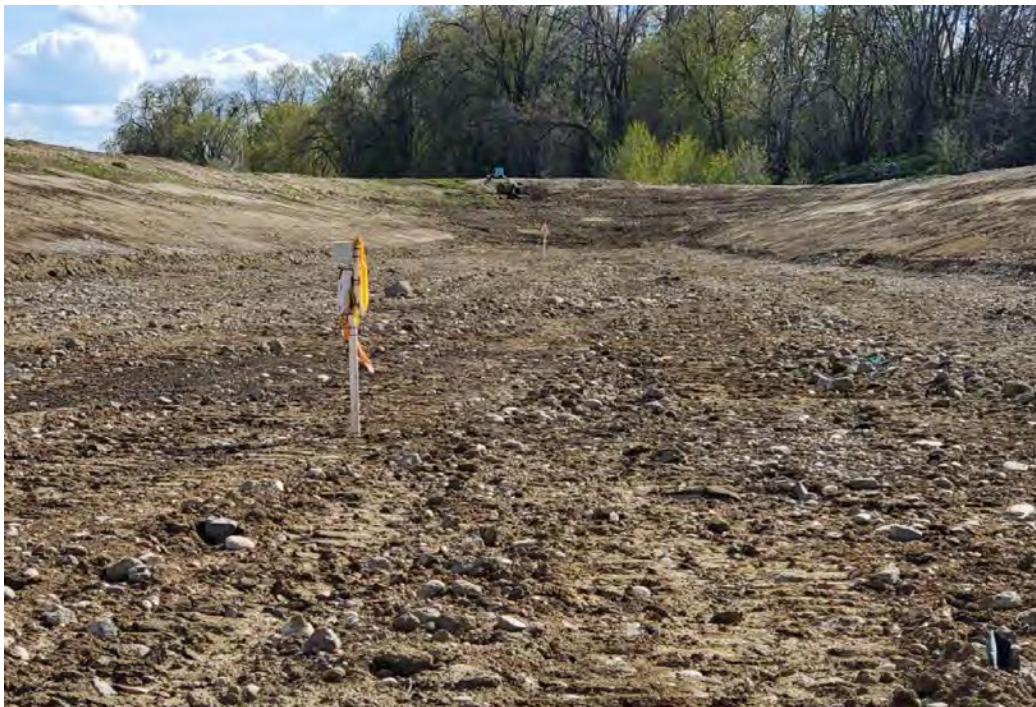
in the bottom of the lagoon (Photograph 3) to provide real-time monitoring of soil moisture levels at depths of 1 foot, 3 feet, and 5 feet bgs. These soil moisture sensors are actively maintained by Agrimanagement, Inc.

Photograph 3
Condition of Lagoon No. 3 Soil Moisture Sensors as Installed

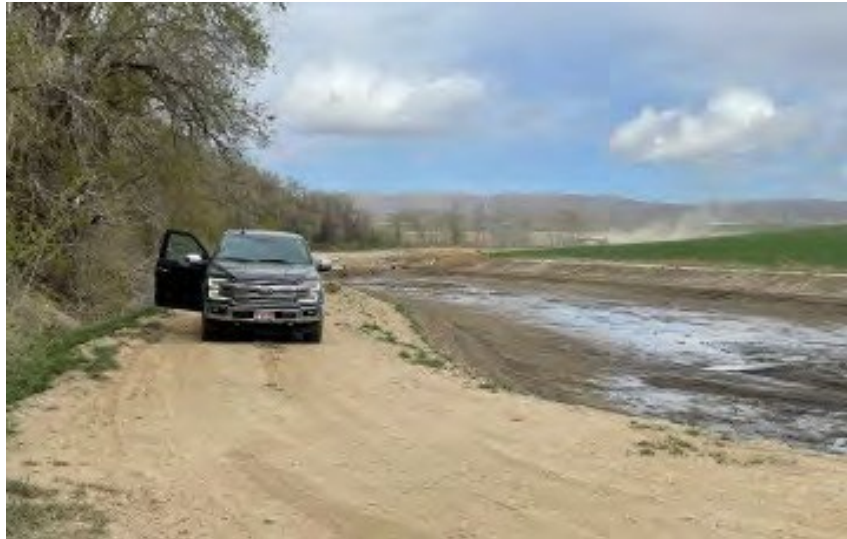
- Lagoon No. 2 has been taken out of service, and liquid manure has been removed. Lagoon conditions as of April 4, 2022, are shown in Photograph 4. Lagoon No. 2 has been added to the Dairy's daily visual monitoring program along with Lagoon No. 3.
- Lagoon No. 3 has been taken out of service but still contains liquid and solid manure (Photograph 5).

Photograph 4
Lagoon No. 2 as of April 4, 2022, After Liquids Removal

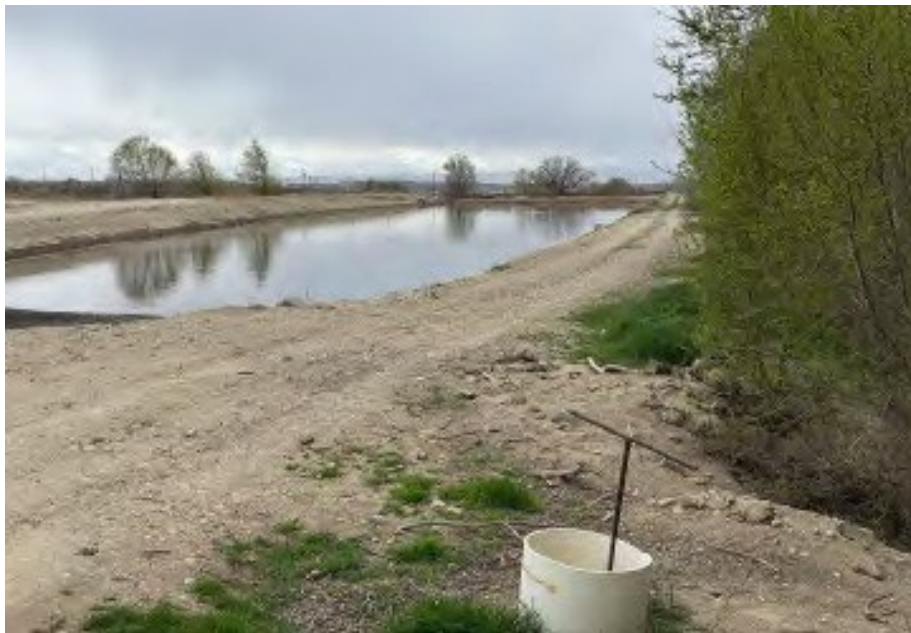
Photograph 5
Lagoon No. 1 as of April 4, 2022

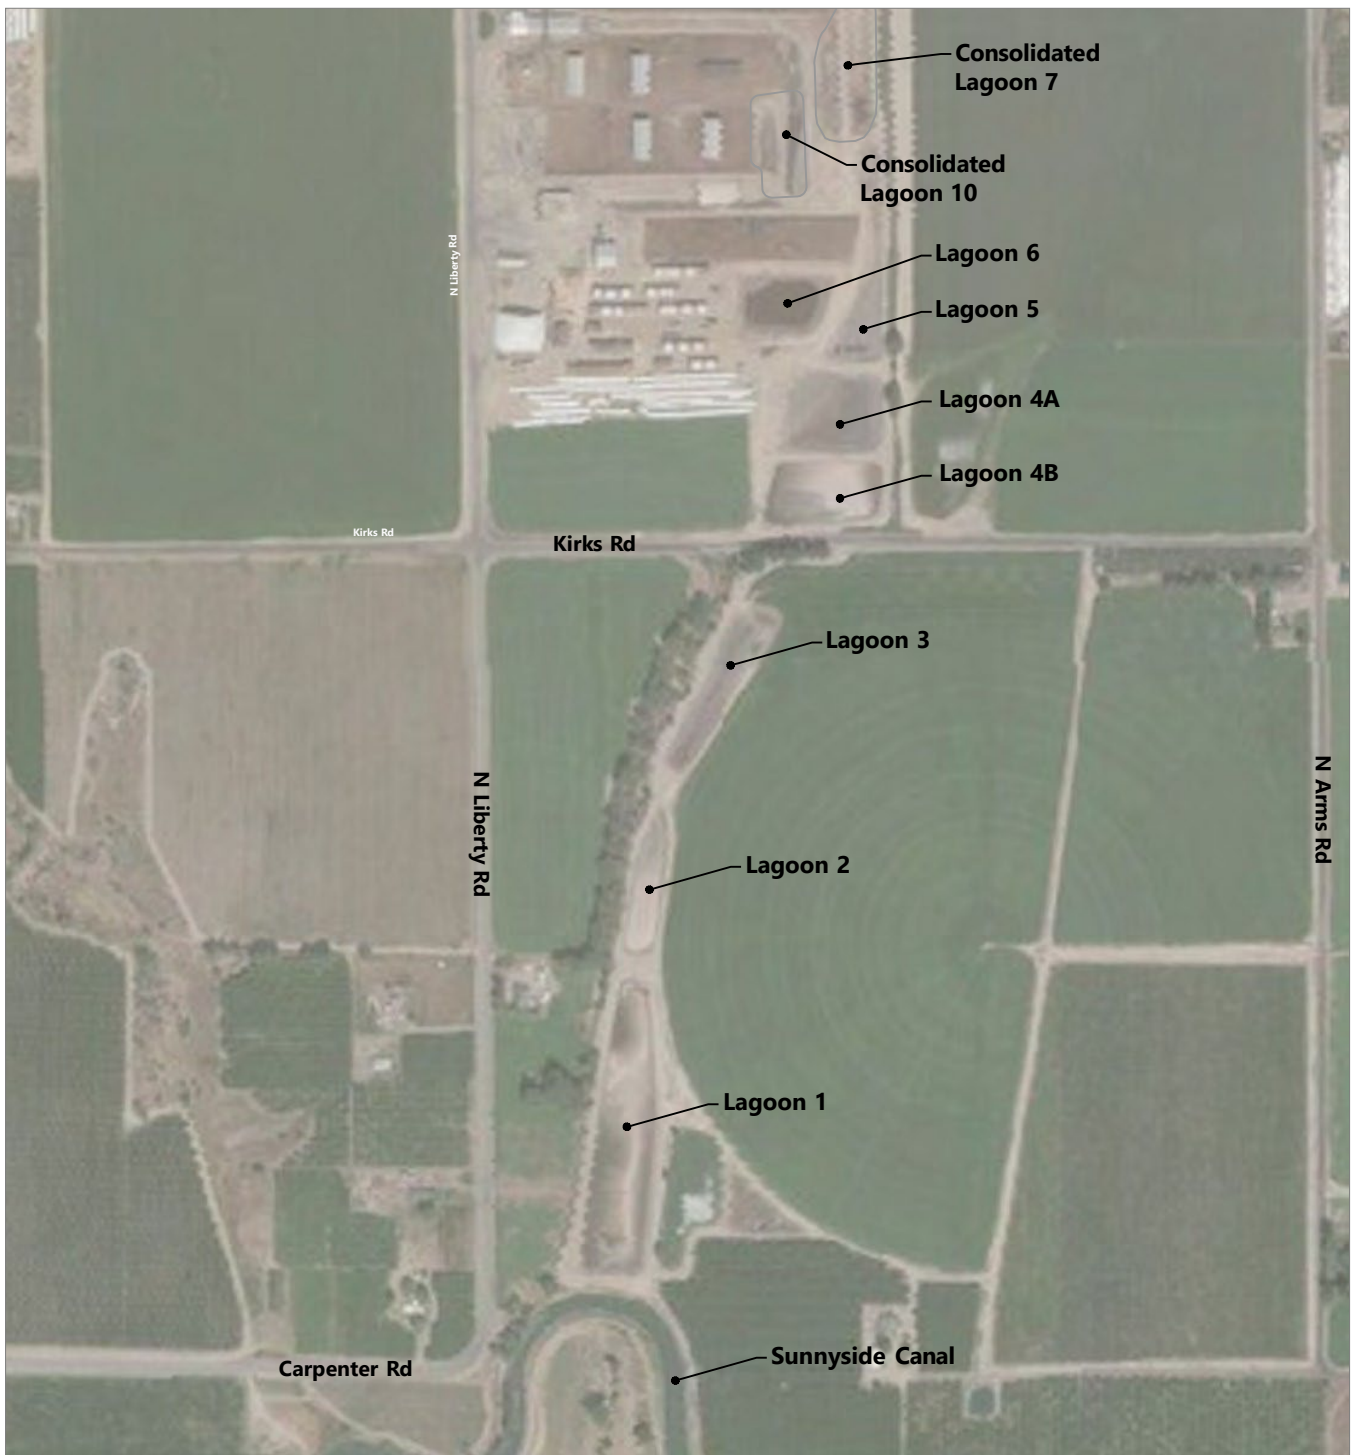
The Dairy is located at 5860 East Zillah Drive Road in Granger, Washington. Figure 1 shows the location of Lagoon Nos. 1, 2, and 3. Estimated dimensions and capacities of the existing lagoons are provided in Table 1.

Figure 1
H&S Bosma Dairy Lagoon Map
 Lagoon No.'s 1, 2 and 3 Abandonment Plan
 H&S Bosma Dairy
